# BELZONA PROVIDES A BULK REPAIR TO A MEAT FREEZER FLOOR

Customer Location: Meat Processing Plant, Florida, USA

Application: FPA-Floor Problem Areas

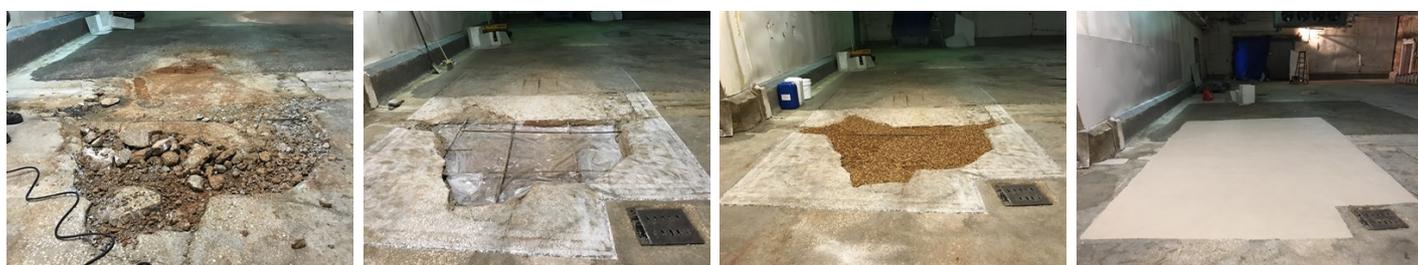
## Photograph Descriptions

Freezer floors have been under 24/7 heavy forklift operation and freezing conditions for more than 40 years. Some areas needed major overhaul. Major concrete damage was found on floors that are indispensable for plant operation. In addition, some localized repairs were needed all over the place. Turnaround time was also an issue with only 3 days to perform repairs.

- \* 1. Condition of the floor after removing covering metal plates ,
- \* 2. Surface preparation on the way ,
- \* 3. Ongoing application (Belzona 4154 and pea-gravel) ,
- \* 4. Finished repair after Belzona 4111 application ,

Application was carried out in accordance with a modified version of Belzona System Leaflet FPA-1. A slurry mix of Belzona 4154 was used to create a foundation where dirt was the substrate. Belzona 4124 was applied over to minimize the cost of deep pour. Belzona 4111 was used as a top layer because of its unique properties.
