# Meat Processing Plant In Need of Belzona On Cooling Towers

ID: 7669

Industry: *Food & Drink*  
Application: *TCC-Tanks and Chemical Containment Areas*

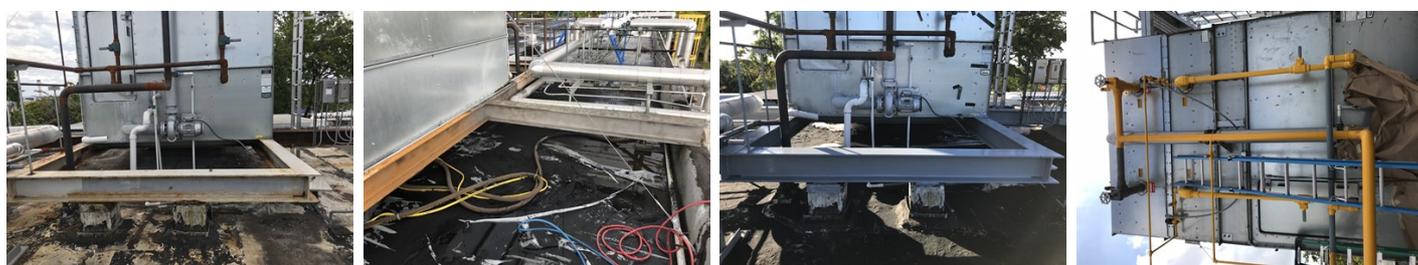
- \* 1. Framework and piping before surface preparation. ,
- \* 2. Ongoing surface preparation using grit-blasting. ,
- \* 3. Framework after application of Belzona 5811 and Belzona 5111. ,
- \* 4. Piping after application of Belzona 3921 and Belzona 5111. ,

The customer had acquired and installed a brand new cooling tower on an existing corroded framework. Piping system was also corroded.

Application carried out in accordance to a modified version of TCC-05. Framework was grit-blasted to NACE 2 Standard. One coat of Belzona 5811 and two coats Belzona 5111 were applied. Some sections of the framework were inaccessible for coating and -in lieu- the access point was sealed with Belzona 3111. Piping system was prepared using power tools. One coat of Belzona 3921 and two coats of Belzona 5111 were applied.
