BELZONA SEALS COOLER SHELL

Industry: *Military*
Application: *HEX-Heat Exchangers*
Substrate: *Carbon Steel*
Products: *Belzona® 1111 (Super Metal)*

Customer Location: *Italian Navy*
Application Date: *October 2005*

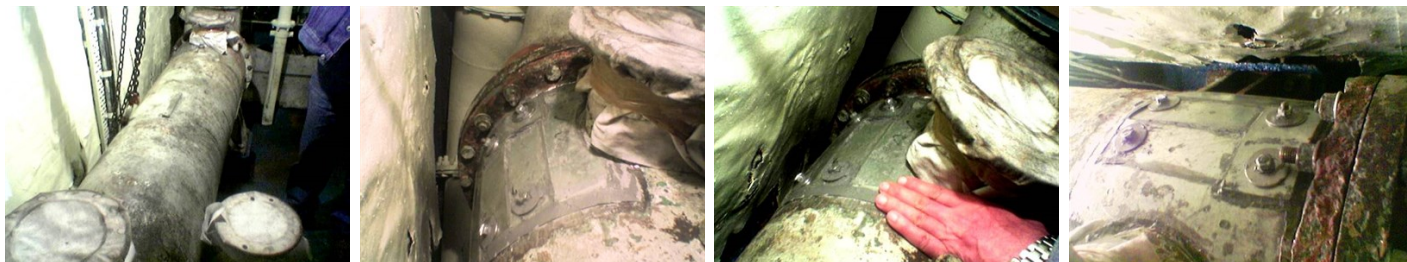
Erosion corrosion had caused hole in the shell of the cooler. Location and timescale made replacement impossible.

* Cooler before repair , * Application underway , * Completing the application , * Close up of the repair ,

Application was carried out in accordance with Belzona System Leaflet HEX-5.

Due to short period in port Belzona was only way to carry out the repairs on the warship with the cooler in place.
