# BELZONA SEALS COOLER SHELL

Industry: *Military*  
Application: *HEX-Heat Exchangers*  
Substrate: *Carbon Steel*  
Products: *Belzona® 1111 (Super Metal)*

Customer Location: *Italian Navy*  
Application Date: *October 2005*

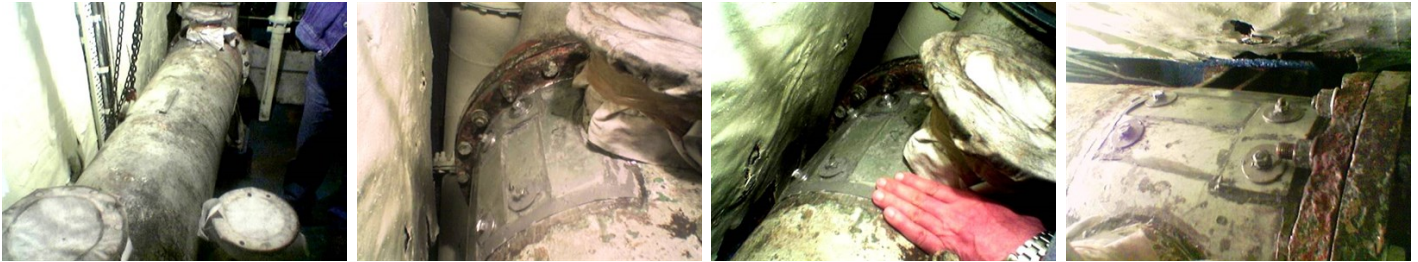
*Erosion corrosion had caused hole in the shell of the cooler. Location and timescale made replacement impossible.*

\* Cooler before repair , \* Application underway , \* Completing the application , \* Close up of the repair ,

Application was carried out in accordance with Belzona System Leaflet HEX-5.

Due to short period in port Belzona was only way to carry out the repairs on the warship with the cooler in place.
