Belzona Granogrip System Provides Safety at a Medical Facility

Application: FPA-Floor Problem Areas

Customer Location: Medical Facility, Washington, USA

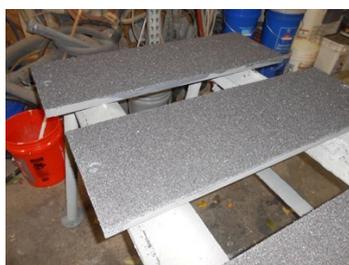
- * 1. Open grate - safety hazard. ,
- * 2. Twelve steel plates after being grit blasted in a machine shop. ,
- * 3. & 4. Sidewalk drain covers in place. ,

New construction of a medical facility. The plans called for open grates over the sidewalk drains. The building inspector rejected the open grates as a safety hazard, especially for high heel shoes.

Determining that the open grates would be a safety hazard and untreated steel would be a slip hazard the engineers called Belzona for a solution. Samples were sent to the building inspector and he chose Belzona 4411 GranoGrip with Belzona 9211 Aggregate.
