# Belzona Applies a Protective System on a Grit Snail

ID: 7671

Industry: *Water / Wastewater*

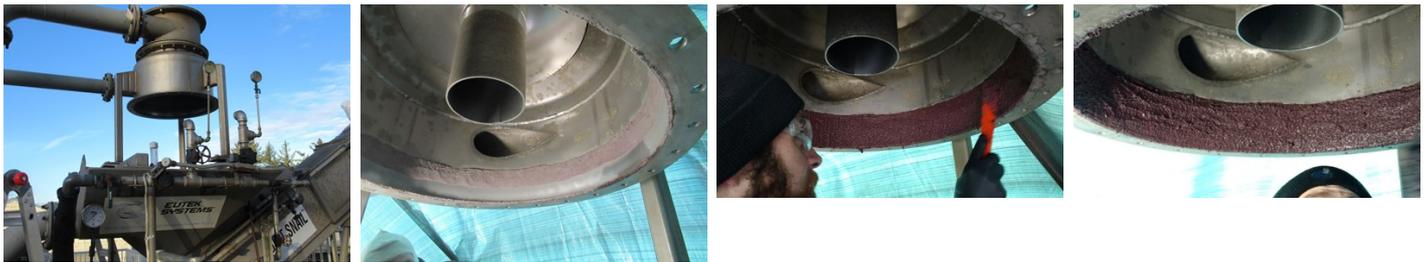
*Grit running through the grit removal system wears through the protective coating and the stainless steel housing.*

- \* 1. Grit Snail ,
- \* 2. Worn area inside grit bowl. ,
- \* 3. & 4. Belzona 1811 (Ceramic Carbide) replaced. ,

The grit removal system, called a Grit Snail, in a waste water treatment plant malfunctioned. The timer had quit working causing the Grit Snail to run constantly causing the factory installed sacrificial coating to wear prematurely through the coating in to the stainless steel housing.

The stainless steel and remaining Belzona 1811 are grit blasted. The 1811 is mixed and applied 1/4" thick on the edges and slightly thicker in the center.

The Grit Snail manufacturer applied a 6" wide band of 1811 in the wear area of the grit bowl. It is a sacrificial coating and must be renewed from time to time. Replacement bowls are quite expensive, thus having a protective coating that extends the service life of the equipment is ideal
