Belzona Applies a Protective System on a Grit Snail

Industry: Water / Wastewater

Customer Location: Oregon, USA

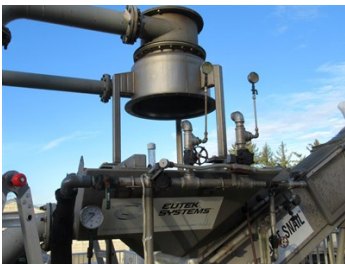
Grit running through the grit removal system wears through the protective coating and the stainless steel housing.

- * 1. Grit Snail ,
- * 2. Worn area inside grit bowl. ,
- * 3. & 4. Belzona 1811 (Ceramic Carbide) replaced. ,

The grit removal system, called a Grit Snail, in a waste water treatment plant malfunctioned. The timer had quit working causing the Grit Snail to run constantly causing the factory installed sacrificial coating to wear prematurely through the coating in to the stainless steel housing.

The stainless steel and remaining Belzona 1811 are grit blasted. The 1811 is mixed and applied 1/4" thick on the edges and slightly thicker in the center.

The Grit Snail manufacturer applied a 6" wide band of 1811 in the wear area of the grit bowl. It is a sacrificial coating and must be renewed from time to time. Replacement bowls are quite expensive, thus having a protective coating that extends the service life of the equipment is ideal
