Belzona Rebuilds Stripped Threads at Power Generator

Industry: Power
Application: ENC-Engines and Casings
Substrate: Steel
Products: * Belzona 1111 (Super Metal) ,
* Belzona 9411 (Release Agent) ,

Customer Location: Washington, USA
Application Date: October 2016

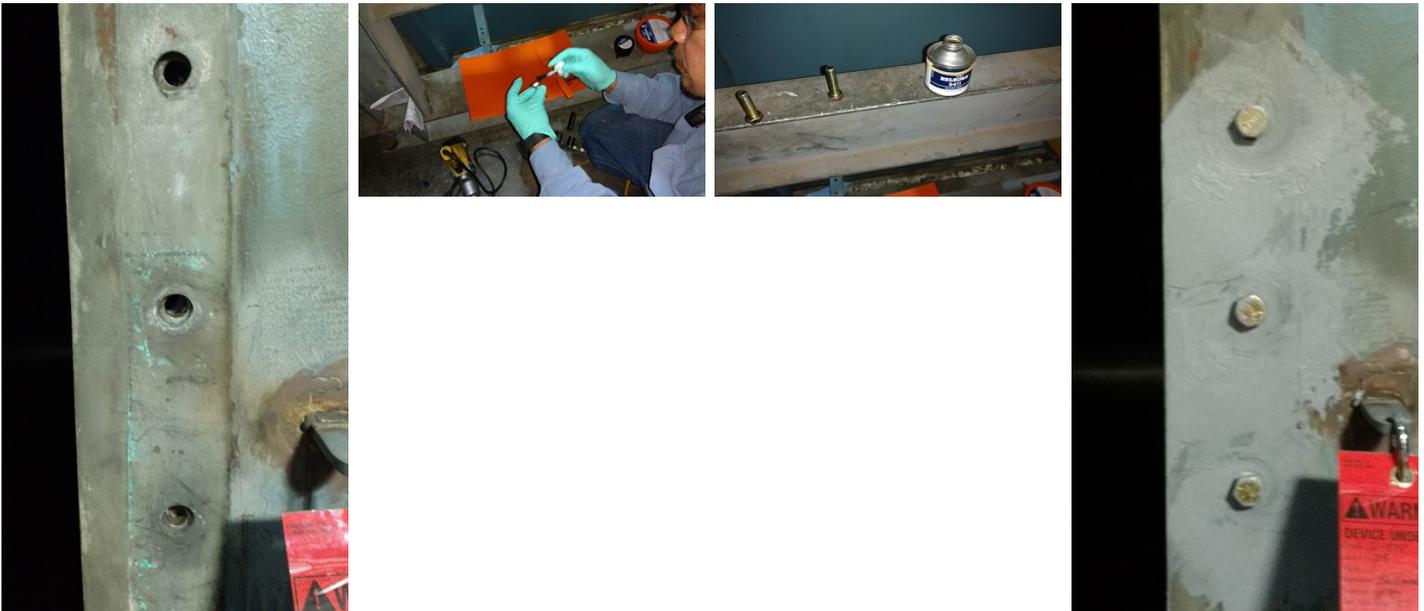
Photograph Descriptions

The door to an industrial blower had quite a few bolts intended to hold the door shut during operation. However over the years of operation and maintenance many of these bolt holes had become stripped and were not firmly holding the door shut.

- * 1. Bolt holes to be repaired by building new threads. ,
- * 2. Coating male bolts with Belzona 9411. ,
- * 3. Coated bolts drying. ,
- * 4. Completed applicaion. ,

The application was carried out in accordance with Belzona Know-How System Leaflet ENC-2. The new bolt was coated with 2 coats of Belzona 9411 and allowed to dry for 30 minutes. While the bolt was drying, the bolt cavity was cleaned using a round wire brush

and a Cleaner/Degreaser. A die grinder with a roughening bit was used to abraid the inner surface of the female bolt holes. Belzona 1111 was then applied to both the female bolt holes as well as to the new male threads that had been coated with Belzona 9411. The coated bolts were then turned into place to incorporate the materials in the female hole and on the male bolt. Once Belzona 1111 was fully cured the male bolts could be removed with a wrench or socket due to the presence of the Release agent and the threads were rebuilt.
