# Belzona Saves Fishing Boat Cooling-Water Circulating Pump

Industry: *Fluid Flow*  
Application: *CEP-Centrifugal Pumps*  
Substrate: *Bronze*  
Products: *\* Belzona 1311 (Ceramic R-Metal) ,*  
*\* Belzona 1321 (Ceramic S-Metal) ,*

Customer Location: *Fishing Company, Netherlands*  
Application Date: *December 2017*

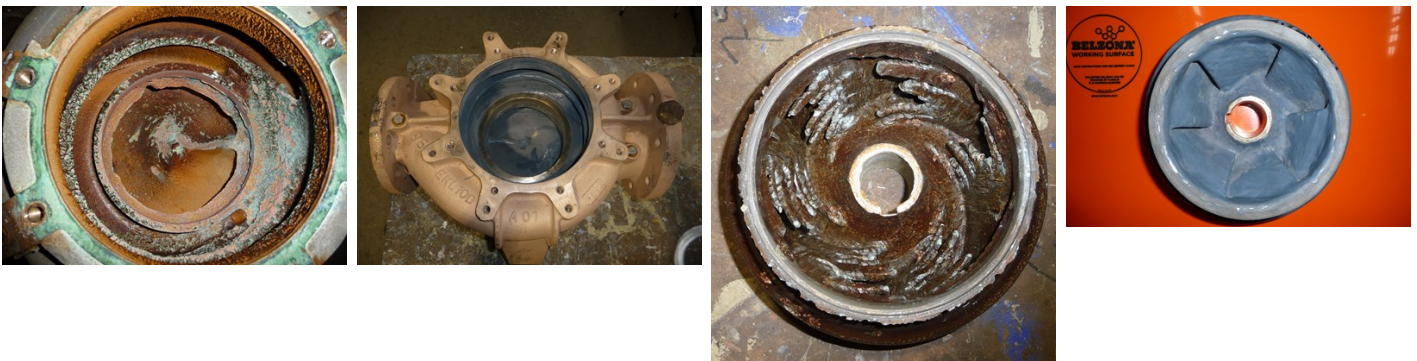
*Cooling-water circulating pump, totally damaged by cavitation.*

- \* 1. Damaged pump casing. ,
- \* 2. Pump repaired and coated. ,
- \* 3. Damaged impeller. ,
- \* 4. Impeller repaired and coated with Belzona. ,

31 year old damaged pump.

Application was carried out in accordance with Belzona system leaflet CEP-3. The pump and impeller prepared by gritblasting. Damage in the pump and impeller was rebuilt with Belzona 1311 and coated with Belzona 1321. The impeller was balanced and pump rebuilt with original parts.
