Belzona SuperWrap Repairs Crude Oil Pipeline

Application: VPF-Valves, Pipes and Fittings

Application Date: November 2016

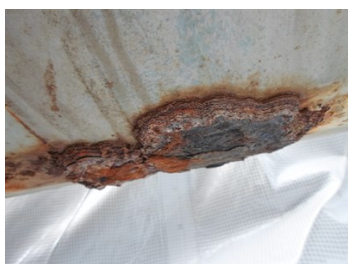
Corrosion Under Insulation had created corrosion scabs to form at the underside of the pipe. Blasting of these scabs was not allowed.

- * 1. Corrosion scab on underside of pipe ,
- * 2. Blasting of pipeline Picture ,
- * 3. Application of SuperWrap II ,
- * 4. Finished Application ,
