# Belzona SuperWrap Repairs Crude Oil Pipeline

ID: 7680

**Customer Location:** Australia  
**Application Date:** November 2016

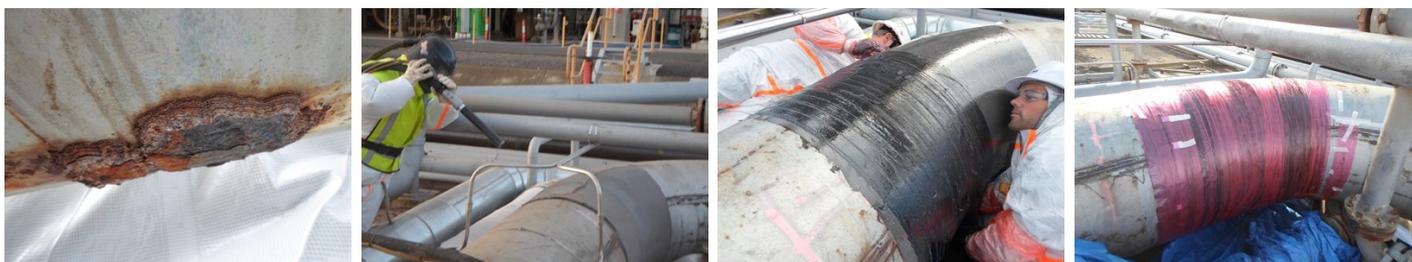
Corrosion Under Insulation had created corrosion scabs to form at the underside of the pipe. Blasting of these scabs was not allowed.

- \* 1. Corrosion scab on underside of pipe ,
- \* 2. Blasting of pipeline Picture ,
- \* 3. Application of SuperWrap II ,
- \* 4. Finished Application ,

**Industry:** Chemical & Petrochemical  
**Application:** VPF-Valves, Pipes and Fittings  
**Substrate:** Carbon Steel  
**Products:** \* Pre-fabricated plates were bonded over the scabs and then blasting could be allowed. Belzona SuperWrap II was applied over the defect areas so stop further corrosion and to keep the pipeline in service for 10 years. ,

Belzona SuperWrap was applied as per a specific Belzona SuperWrap method statement and design.
