BELZONA SUPERWRAP II SUCCESSFULLY TACKLES A LIVE LEAK REPAIR

ID: 7684

Fiberglass 36" pipe of a cooling tower.

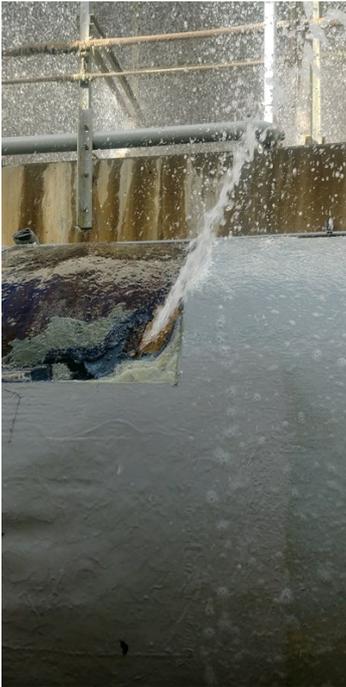
Photograph Descriptions

The pipe burst after an outage causing the plant to shutdown.

* 1. Showing damage. 2. Surface preparation. 3. Plate bonding with Belzona 1212. 4. Superwrap II System installed. ,

The repair area and a pre-fabricated steel plate were sandblasted. The steel plate was bonded with Belzona 1212 followed by an application of the Superwrap II System.

The pipe burst after another repair had taken place. Belzona Team responded to an emergency call from this Customer promptly, and carried out the repair in 5 hours within the same day as the call was received. The cooling tower and the plant were back on line the next morning.
