OLD PUMPS REPAIRED, PROTECTED AND IMPROVED WITH BELZONA

Industry: Marine
Application: CEP-Centrifugal Pumps
Substrate: Cast Iron
Products: * Belzona 1121 ,
* Belzona 1341 ,

Customer Location: Dry Dock Facility, BC, Canada
Application Date: August 2017

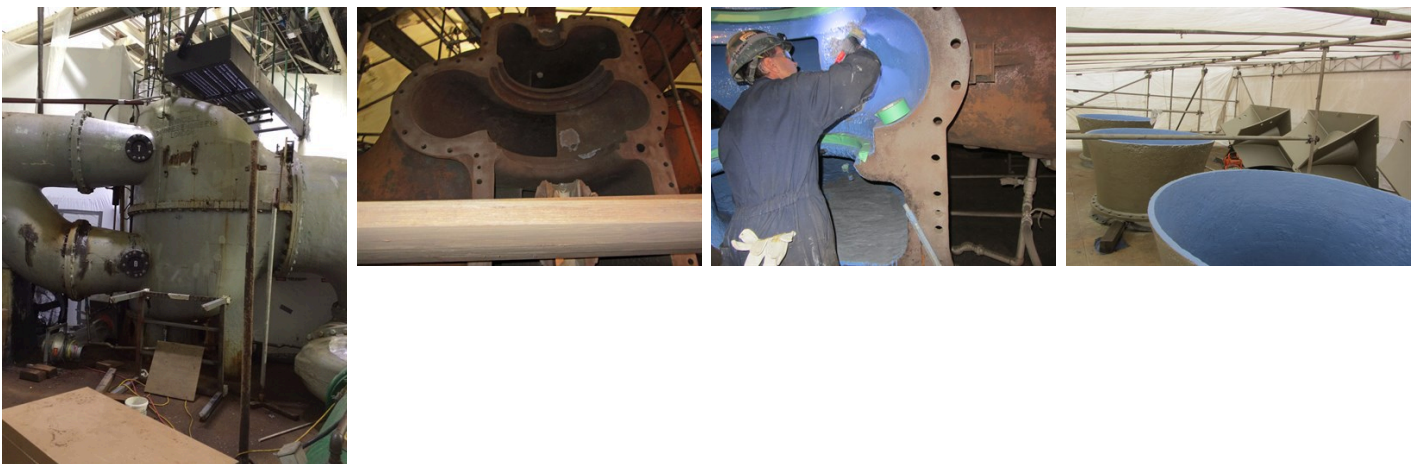
Photograph Descriptions

The pumps were damaged by erosion-corrosion due to the salt content in the water they were pumping. Holes had developed in some of the cast iron casings and stuffing boxes also needed major rebuilding. Although the pumps were old, replacing them was not possible.

- * 1. 30 ft high pump. ,
- * 2. Showing damage from erosion-corrosion. ,
- * 3. Application of Belzona 1341 Blue in progress. ,
- * 4. Complete application. ,

The application was carried out in accordance with modified versions of Belzona Know-How System Leaflets CEP-1 and CEP-3. Belzona 1121 was used to rebuild and repair the eroded surfaces. Belzona 1341 was used to improve the pumps performance. Due to the large size of the pumps and related inlets and outlets, it was decided to blast in stages and then protect with Belzona 1341. This was followed by a skim coat of Belzona 1341/1121 mixture to fill in most of the lower depressions. The remaining voids were filled with Belzona 1121. The units received a final brush blast before 2 successive coats of Belzona 1341 grey and blue were

applied.
