# BELZONA PLATE BONDING APPLICATION HELPS A MILITARY VESSEL DEPLOY ON SCHEDULE

ID: 7686

Industry: *Military*  
Application: *SOS-Ships and Offshore Structures*

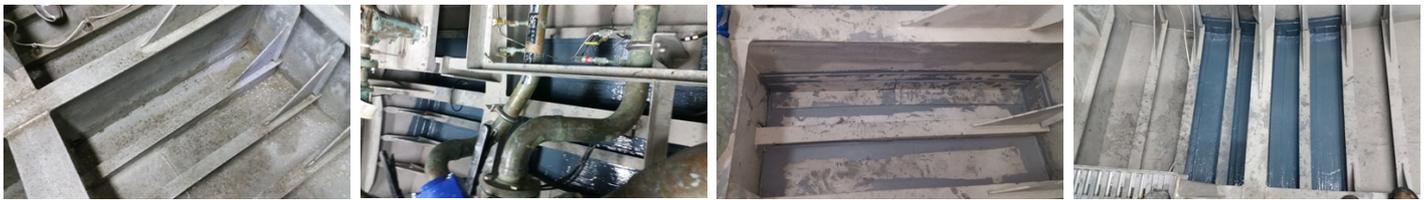
## Photograph Descriptions

*Water was leaking into two compartments, located against the aluminum hull of the ship (approximately 400 Square Feet of total repair area). The shell of the hull and stiffeners in the spaces were corroding from salt water, which was collecting in lower reaches of the space. The corrosion had progressed to the point that the water was leaking and traveling into adjacent hull locations. Stitch welding of the vertical stiffeners to the shell was hiding much of the corrosion.*

\* 1. Showing damage caused by corrosion. 2. 1st coat of Belzona 1321 applied. 3. Doubler plates embedded with Belzona 1111. 4. Complete application. ,

The application was carried out in accordance with a modified version of Belzona Know-How System Leaflet SOS-1, SOS-2. Belzona 1111 was applied to prepared substrate and prepared plates – to bond doubler plates to the shell, the bulkhead and into the corners with 90 Degree angle plates. A top coat of Belzona 1321 was applied to all repair areas – to allow for easier inspection of the repairs and to provide a more professional appearance of the completed repair area.
