BELZONA COLD BONDING REPAIRS AN EXHAUST FLUE

ID: 7690

Customer Location: Zinc and Lead Smelting Complex, BC, Canada

Application: VPF-Valves, Pipes and Fittings

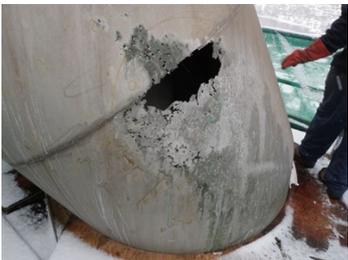
A hole was created in the wall of the flue at an elbow; due to the location of the hole, it was not noticed until it was nearly one foot across. Upon closer inspection, it was found that a large section of the flue wall in this area was pitted and weakened, with many small holes developing.

View of small holes indicating extensive pitting of the interior surface

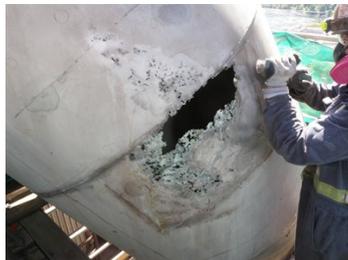
Initial surface preparation using a wire brush

Patch plates were pre-designed to fit the flue elbow, and blasted prior to the application. The application was performed from scaffolding with flue in operation. Surface preparation was limited due to the necessity of avoiding any sparks which could be drawn into the hole; the use of a hand-held random orbit sander equipped with 40-grit paper was approved, and this was used along with handheld wire brush for prep on the exterior surface of the flue. After prep, the flue exterior surface was coated by brush with Belzona 5841, which is tolerant of both minimal surface prep and the temperatures at which this flue operates, with the aim of improving adhesion of Belzona 1121 to this surface. Belzona 1121 was mixed and applied to the back of the first patch plate to a thickness of approximately 3/4", and this plate was then lifted by two people (using handles welded to the plates for this purpose) and positioned while a third person installed and tightened band clamps to hold the plate in place during cure. Five separate patch plates were installed in sequence, including a strip covering the joint between two adjacent plates.

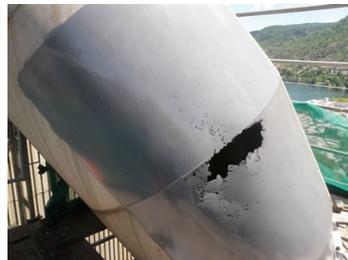
Prepared area coated with Belzona 5841

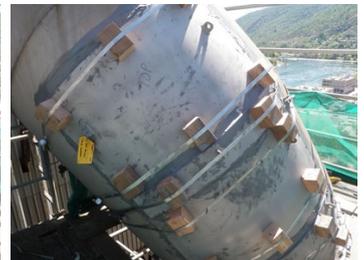
All 5 plates bonded in place; application is completed

The repair was inspected several times since application in June 2017 and was performing perfectly at the time of inspection.
