Belzona Composite Ferry Wrap

ID: 7698

Industry: *Transport*
Application: *VPF-Valves, Pipes and Fittings*
Substrate: *Mild Steel*
Products: ** Belzona 1121 (Super XL-Metal) ,*
** Belzona 5821 ,*

Ferry Pipe

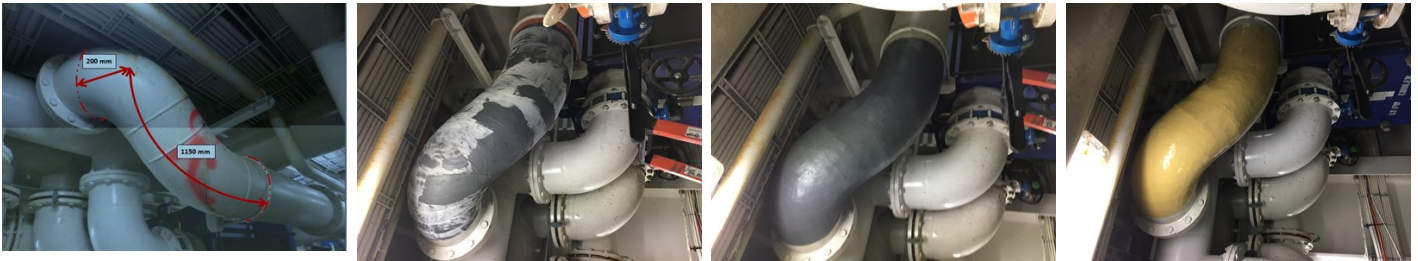
Photograph Descriptions

Suffering from external corrosion

- * 1. Damaged pipe ,
- * 2. Belzona 1121 wrap in progress ,
- * 3. Composite Wrap complete ,
- * 4. Completed application ,

The application was carried out in accordance with Belzona system leaflet VPF-11. This was followed by over-coating with Belzona 5821.
