Belzona Composite Ferry Wrap

Ferry Pipe

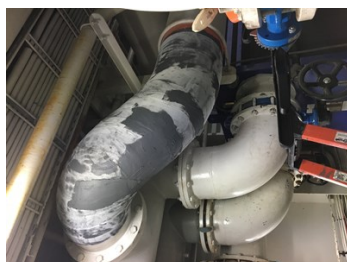
Suffering from external corrosion
