# Belzona Supports Effluent Tank

Industry: Oil & Gas  
Application: TCC-Tanks and Chemical Containment Areas  
Substrate: Concrete  
Products: \* Belzona 4141 (magma Hi-Build) ,  
\* Belzona 5811 (Immersion Grade) ,

Customer Location: Kuwait  
Application Date: February 2018

Damaged concrete supports of effluent water vessel

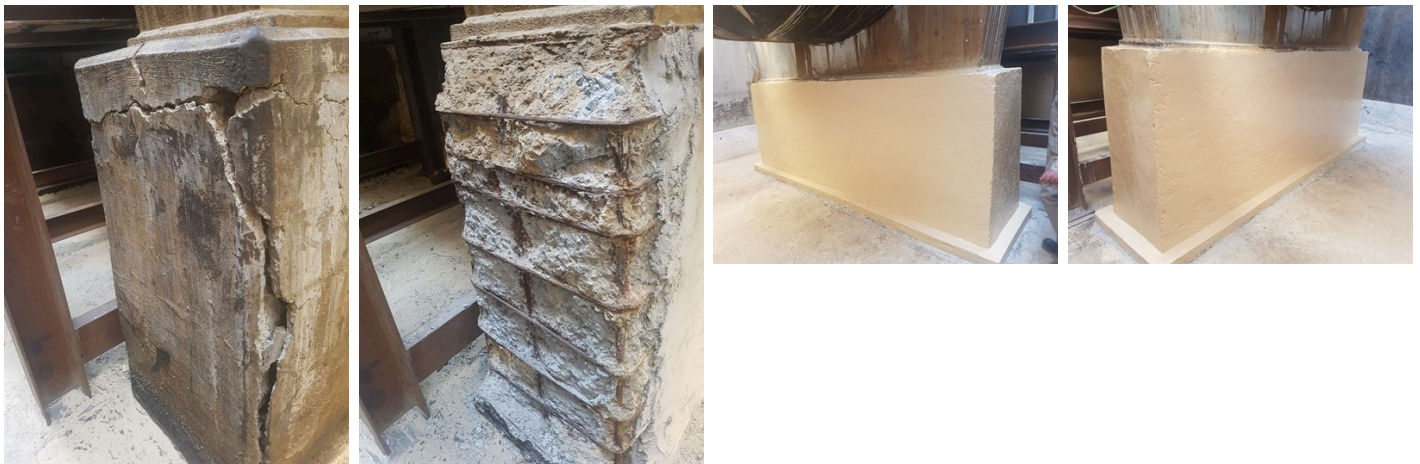
Water ingress and weathering had caused corrosion of the reinforcement bar, leading to cracking and spalling of the concrete supports.

\* Image 1 - Cracked and Spalling Concrete Image 2 - Damaged and loosely adhered concrete removed Images 3 & 4 - Concrete supports repaired and coated ,

Damaged and loose concrete was removed before the surface was abraded using mechanical tools to clean and roughen the surface, and remove corrosion from the reinforcement bar. Compressed air was then used to remove dust. The surface was primed with Belzona 4911, and Belzona 4141 used to rebuild the surface to the original dimensions. For additional protection from weathering and potential spillage from the tank, 2 coats of Belzona 5811 were added to protect the vessel supports.

Using conventional concrete to repair the area would have required a long time frame and the construction of formers to hold the concrete in place during the curing period. The resulting repair would also have suffered the same problems as the original concrete supports. Due to the superior adhesion and protective qualities of Belzona 4141, this was the preferred solution over the conventional concrete repair. The easy rebuilding qualities and fast curing time of the Belzona solution was an added bonus for the customer.
