Belzona Supports Effluent Tank

Industry: Oil & Gas
Application: TCC-Tanks and Chemical Containment Areas
Substrate: Concrete
Products: Belzona 4141 (magma Hi-Build),
Belzona 5811 (Immersion Grade),

Customer Location: Kuwait
Application Date: February 2018

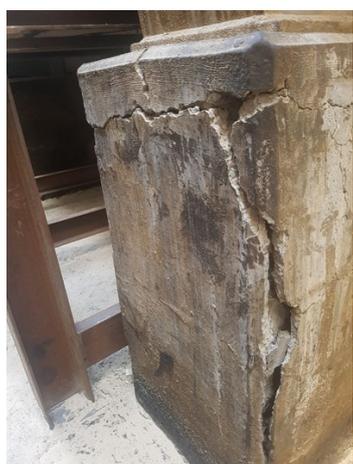
Water ingress and weathering had caused corrosion of the reinforcement bar, leading to cracking and spalling of the concrete supports.

Cracked and Spalling Concrete

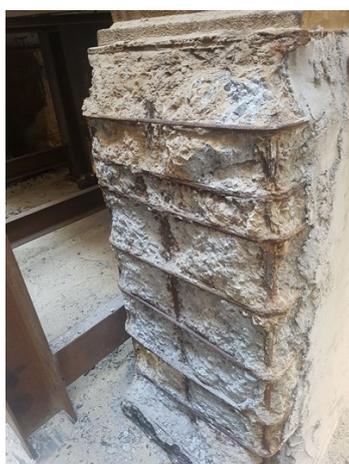
Damaged and loosely adhered concrete removed

Damaged and loose concrete was removed before the surface was abraded using mechanical tools to clean and roughen the surface, and remove corrosion from the reinforcement bar. Compressed air was then used to remove dust. The surface was primed with Belzona 4911, and Belzona 4141 used to rebuild the surface to the original dimensions. For additional protection from weathering and potential spillage from the tank, 2 coats of Belzona 5811 were added to protect the vessel supports.

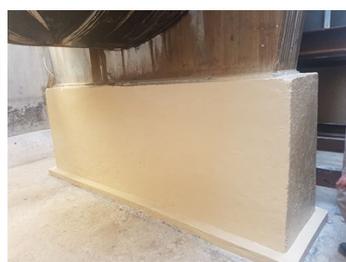
Concrete supports repaired and coated

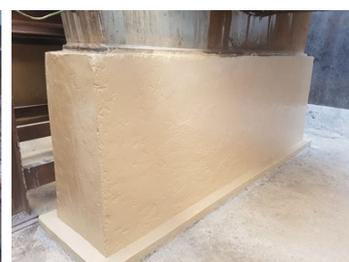
Concrete supports repaired and coated
