Belzona Supports Effluent Tank

ID: 7699

Damaged concrete supports of effluent water vessel

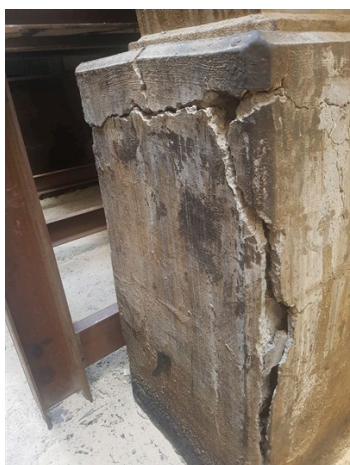
Water ingress and weathering had caused corrosion of the reinforcement bar, leading to cracking and spalling of the concrete supports.

Cracked and Spalling Concrete

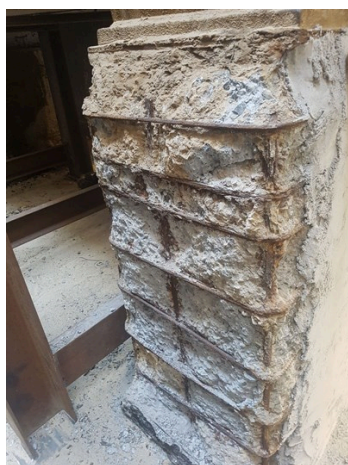
Damaged and loosely adhered concrete removed

Damaged and loose concrete was removed before the surface was abraded using mechanical tools to clean and roughen the surface, and remove corrosion from the reinforcement bar. Compressed air was then used to remove dust. The surface was primed with Belzona 4911, and Belzona 4141 used to rebuild the surface to the original dimensions. For additional protection from weathering and potential spillage from the tank, 2 coats of Belzona 5811 were added to protect the vessel supports.

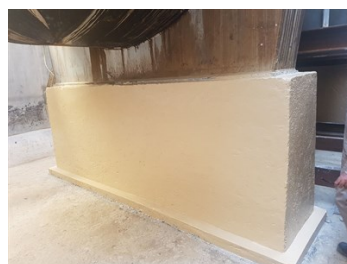
Concrete supports repaired and coated
