# Belzona Enhances Hospital Steps

ID: 7701

Industry: *Buildings & Structures*  
 Application: *FPA-Floor Problem Areas*  
 Substrate: *Concrete*  
 Products: *Belzona 5821,*  
*Belzona 9211 (Supergrip Aggregate),*

Customer Location: *Glasgow, UK*  
 Application Date: *March 2018*

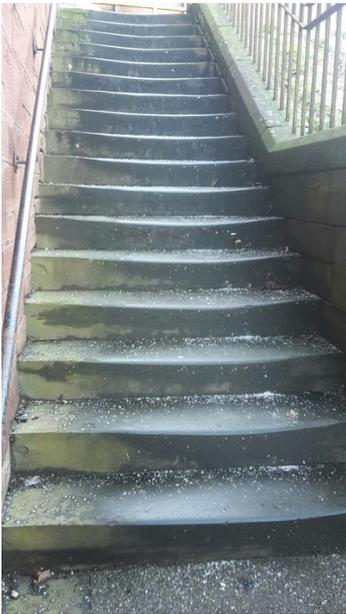
A potential slip hazard had been noted on several sets of sandstone steps. Due to the enclosed area it was often damp or icy in the winter. A durable long lasting solution was required to ensure the slip hazard could not reoccur in the future.

Slippery steps before

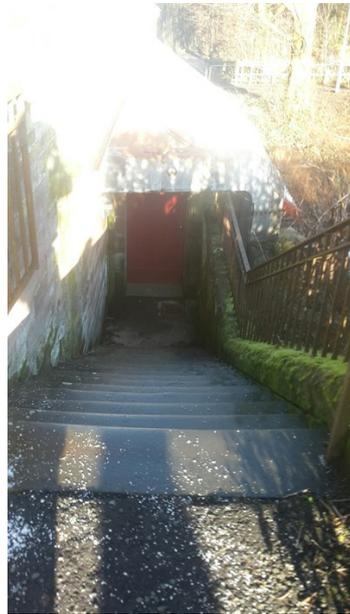
Finished application

The steps were marked out & prepared using a floor grinder. Belzona 5821 was then applied as a 1 coat system. Immediately following this Belzona 9211 aggregate was blinded into the coating & tamped down.

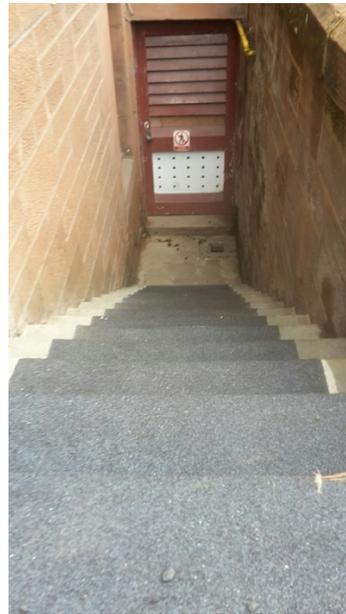
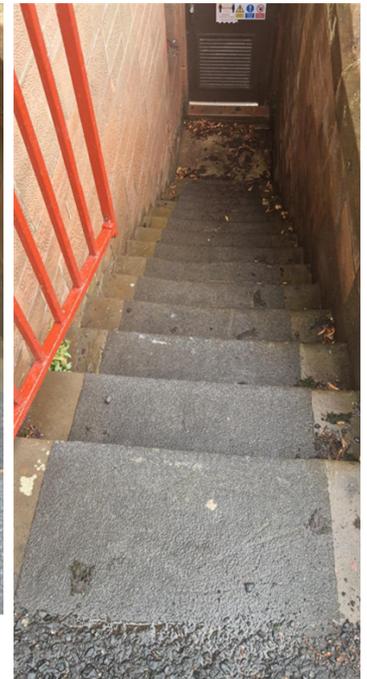
The steps revisited 7 years after the application
