SPALLED CONCRETE IN A HIGH TRAFFIC AREA RECOVERED AND PROTECTED BY BELZONA

ID: 7714

Industry: Pulp & Paper
 Application: FPA-Floor Problem Areas
 Substrate: Concrete
 Products: * Belzona 5231 (SG Laminate) ,
 * Belzona 5233 ,

Customer Location: Oregon, USA
 Application Date: November 2017

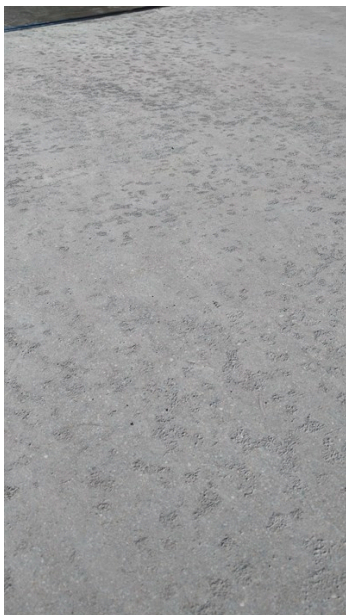
Fresh concrete section that was poured developed severe spalling and pits. The customer was concerned that this would open up this section for water to penetrate the pad and through the winter the water would freeze and cause even worse damage. The customer required a material that would not be smooth and slippery, and they wanted it to "look like concrete".

- * 1. Original condition showing the spalling and pitting. ,
- * 2. Belzona 5231 applied, the aggregate being spread. ,
- * 3. Belzona 5231/5233 application complete. ,
- * 4. The application after 6 months. ,

We waited for the fresh concrete to fully cure. Surface prep was done with hand grinders to remove all of the surface laitence and loose material from the spalling. There were still some areas of deeper pitting that we addressed by "flooding" on the first layer. The first layer, Belzona 5231 in light gray color, was applied using a squeegee to spread it around, and smoothed over using a roller. Then a light gray quartz aggregate spread by hand to refusal. We allowed that to cure for a couple hours, and then we were able to vacuum the excess aggregate off the top and apply the second layer, Belzona 5233 Clear with rollers and allowed to fully cure.
