Potable Water Tank Repaired with Belzona Composite Patch Stands the Test of Time

Industry: Oil & Gas
 Application: TCC-Tanks and Chemical Containment Areas
 Substrate: HDLPE
 Products: * Belzona 1111 (Super Metal) ,
 * Belzona 9341 (Reinforcement Tape) ,
 * Belzona 9111 (Cleaner/Degreaser) ,

Customer Location: Gulf of Mexico, USA
 Application Date: February 2017

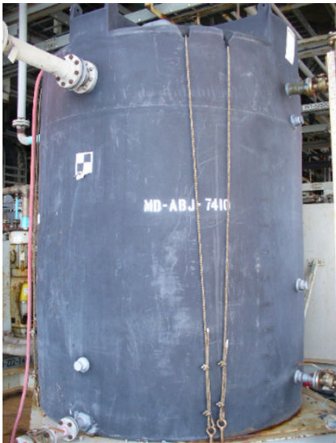
- * 1. Potable water tank overview ,
- * 2. Location of the leak (a tiny wisp of water pushing out) ,
- * 3. Belzona composite patch repair completed ,
- * 4. Belzona composite patch repair holding 1 year later ,

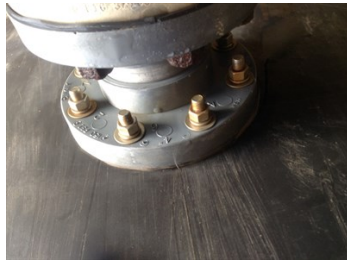
UV Damage and possible loading forces to the HDLPE polymer tank resulted in a hairline crack above a 4" flange. Replacement of the tank was several years away still and the repair method had to be compliant with potable water standards.

The application was carried out in accordance with Belzona Know-How System Leaflet TCC-1 with a composite patch consisting of

Belzona 1111/9341.

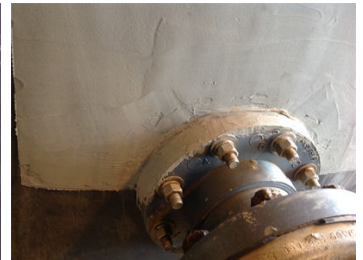
This application is still holding well over a year later, saving this platform from having to complete a costly replacement prior to the scheduled outage. This repair method has become a standard and they keep contingency repair kits on board at all times.
