# BELZONA REPAIRS LEAKING CPVC COOLING WATER LINES

ID: 7721

Cooling water line for biomass power generation turbine.

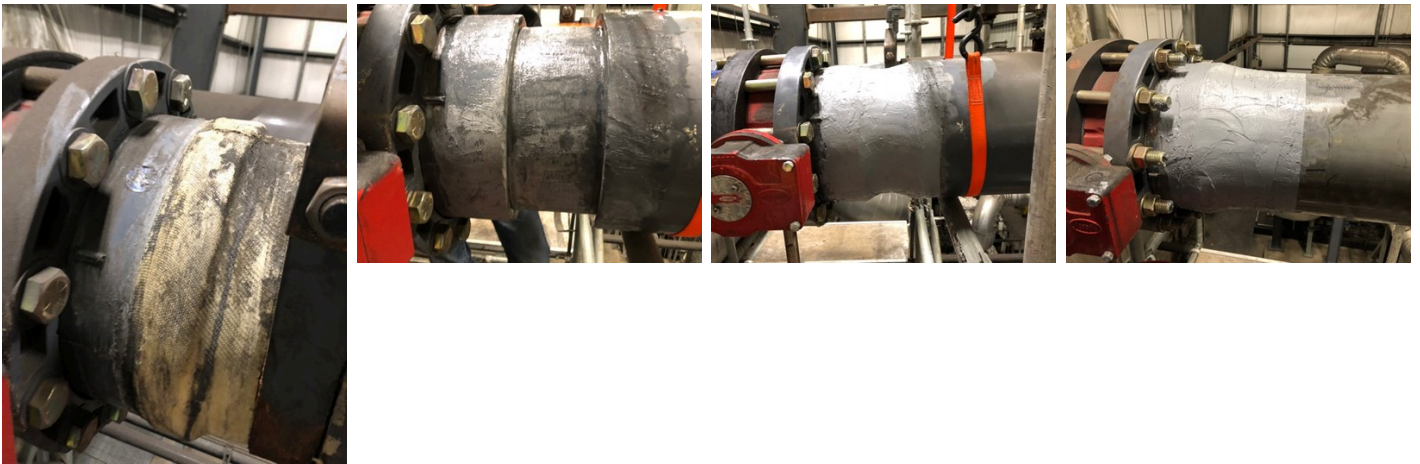
The customer was experiencing significant water leaks from a 250mm (10 inch) cooling water line, through an existing non-Belzona wrap repair. The leaks were occurring at the fitted flanges of two separate lines. Due to the severity of the leak, the biomass generation turbine was taken out of service until a Belzona repair could be completed.

- \* 1. Water leaking through existing wrap repair. ,
- \* 2. Cleaning CPVC with Belzona 9111. ,
- \* 3. Completed Belzona 1161 repair. ,
- \* 4. Completed Belzona 1161 repair to a parallel line. ,

Application was carried out in accordance with Belzona System Leaflet VPF-11. The substrate was profiled using a beaver file hand tool. The repair area was marked and cleaned with Belzona 9111, and allowed to dry. The slow trickle of water around the flange fitting was stopped using Belzona 1212. Additional Belzona 1212 was used to chamfer the flange fitting to the main CPVC line.

Belzona 1161 was then brushed over the repair area then wrapped with one layer of Belzona 9341 wetted with additional Belzona 1161. Additional Belzona 1161 was used to fully encapsulate the reinforcing tape.

The entire repair was completed in five hours. The biomass generation turbine was started several days later with no leaking visible on the cooling water lines.
