# BELZONA REPAIRS A HEAVILY DAMAGED MARINE FENDER

ID: 7723

Industry: Marine  
Application: SOS-Ships and Offshore Structures

Customer Location: Washington, USA  
Application Date: June 2018

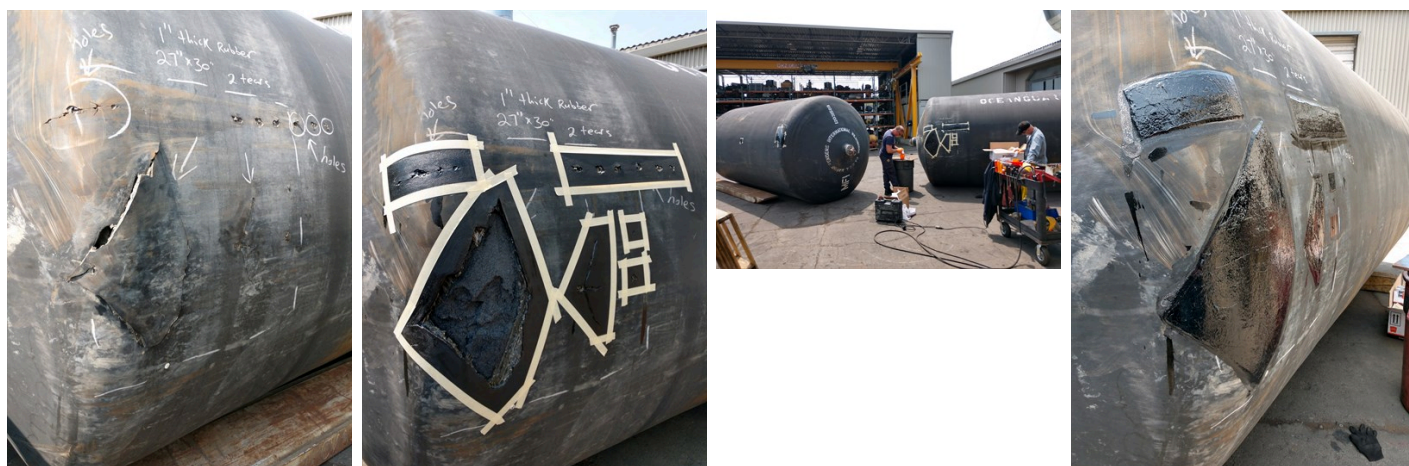
Something sharp impacted these fenders hard enough to rip and tear through the 1.5" heavy duty rubber. This would allow water to saturate the foam core which in turn will cause the fender to sink rather than float

- \* 1. Original damage. ,
- \* 2. Prepped, conditioned, and taped. ,
- \* 3. Applying the Belzona 2111 D&A Hi-Build Elastomer. ,
- \* 4. Completed application. ,

The application was carried out in accordance with Belzona System Leaflet SOS-12. First, all loose and damaged areas and pieces were removed. The surface was then prepared with an MBX Bristleblaster to a nice rough "feathery" finish. Belzona 2911 was then applied to the prepped area and then taped off to provide clean lines for the repair. Belzona 2111 was mixed, 500 gr unit at a time, and allowed to cure as per the Instructions For Use. It was then worked into the surface and built up to bring it back to its original

form. Finally, each location was overlaid with Belzona 9341 to give the repair some added strength. The tape was removed and the application was smoothed by a Belzona applicator.
