# BELZONA SAVED HAWSE HOLES OF A FISH PROCESSING VESSEL

ID: 7724

Hawse hole on a 225' fish processing ship.

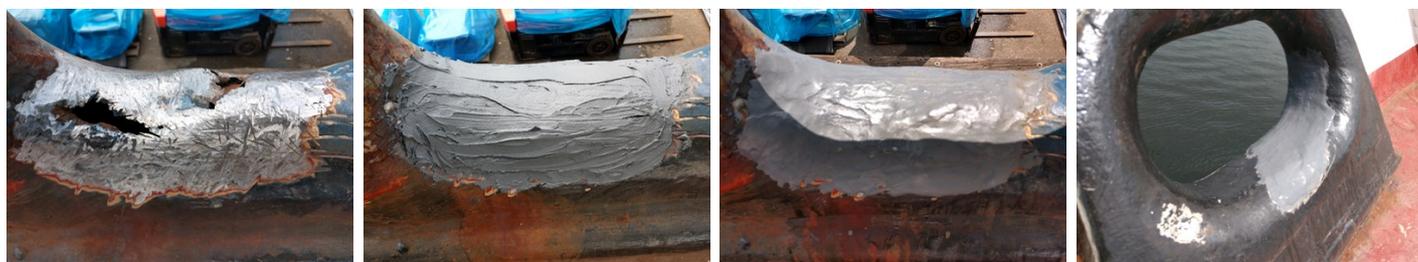
While the ship was at a shipyard, someone used a steel cable to secure the ship to the dock. The motion of the sea caused the steel cable to work back and forth like a saw and caused heavy damage to two of the hawse holes, one considerably worse than the other. Usually, a 3" rope is used to secure the boat, but after the damage had been done, there were sharp edges that would have frayed or even cut a rope had it been placed through the hawse hole. This presents a major problem since while the ship is processing salmon in Alaska, it must get tied up, and this could cause the ship to break loose during a bad Alaskan storm.

- \* 1. Original damage to the Hawse hole. ,
- \* 2. Belzona 1311 is applied. ,
- \* 3. Hawse hole repair complete. ,
- \* 4. Hawse hole repair complete. ,

A grinder was used to remove the rust and loose material and provide a super rough finish for an optimum mechanical bond. Belzona 1311 was mixed in 3 separate batches. The first batch to fill in the deep areas and rebuild closer to the original profile on the hawse hole with the worst damage. The second batch was to repair the least damaged hawse hole. The final batch was to skim coat and finish off both locations to the proper, original profile. After allowing Belzona 1311 to cure for a short time while wearing a rubber glove, and using some soapy water, Belzona 1311 was smoothed down to ensure there would be no damage to the ropes that get used.
