Belzona Chocking Compound Stabilizes Lathe

ID: 7725

Industry: *Pulp & Paper*
Application: *GSS-Gaskets, Seals and Shims*
Substrate: *Concrete*
Products: ** Belzona 7111 (Industrial grade) ,*

Customer Location: *Poland*
Application Date: *March 2018*

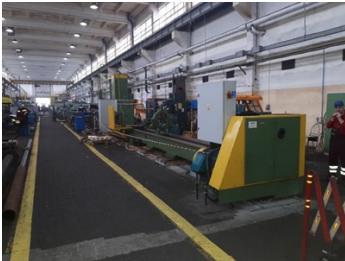
- * The new lathe to be chocked. ,
- * The application is underway. ,
- * The completed solution. ,

The Belzona solution secured the equipment for the long-term. Normally the machine would be bolted to the floor, which doesn't prevent corrosion or damage to the baseplate due to vibration.
