Belzona Chocking Compound Stabilizes Lathe

ID: 7725

Industry: *Pulp & Paper*
Application: *GSS-Gaskets, Seals and Shims*
Substrate: *Concrete*
Products: ** Belzona 7111 (Industrial grade) ,*

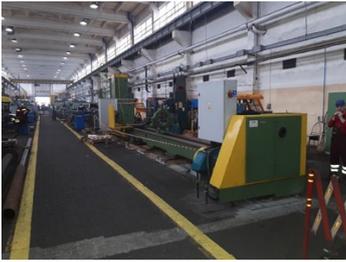
- * The new lathe to be chocked. ,
- * The application is underway. ,
- * The completed solution. ,
