CIP bund coating

ID: 7726

Industry: Chemical & Petrochemical
Application: TCC-Tanks and Chemical Containment Areas
Substrate: Concrete
Products: * Belzona 4131 (Magma-Screed) ,
* Belzona 5811 (Immersion Grade) ,

Customer Location: Scotland
Application Date: April 2018

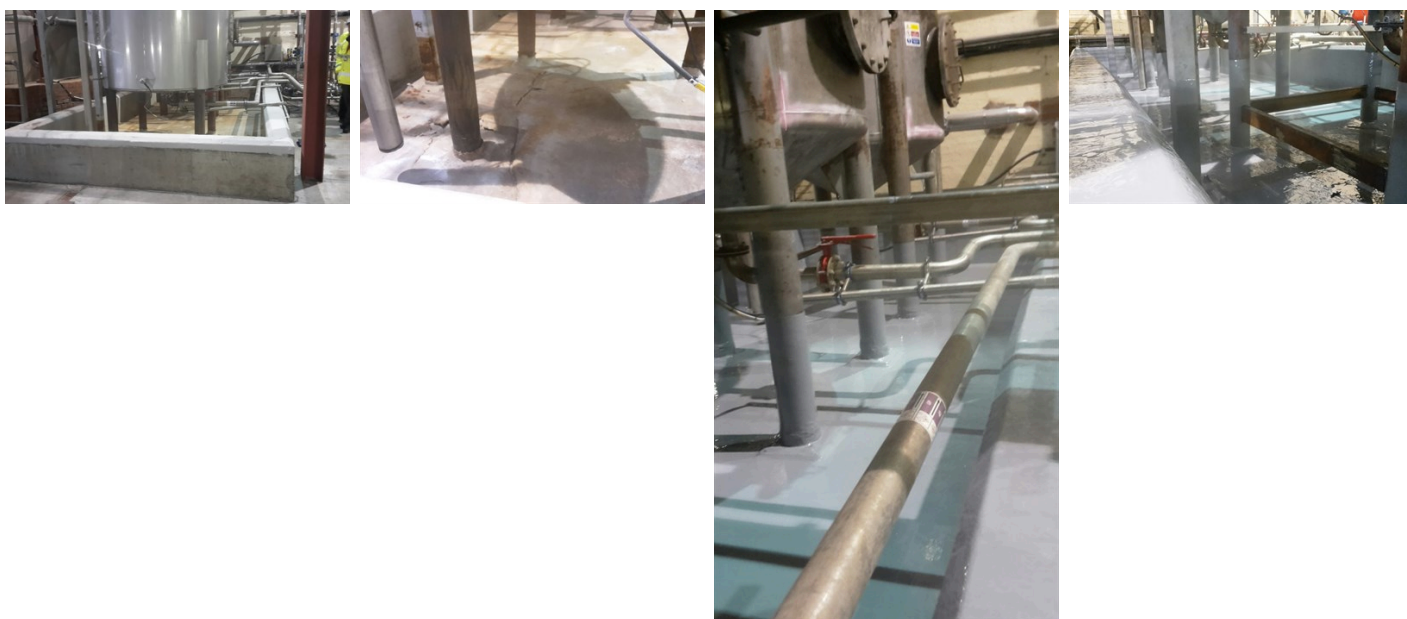
Photograph Descriptions

* 1 - overview of the bund 2 - failed GRP lining showing cracks 3 - Two coats system of Belzona 5811 applied to the concrete & onto the tank legs 4 - completed application ,

A CIP chemical bund had a GRP lining in place. This lining had started to break down & de-laminate on large areas of the bund.

Application was carried out in accordance with Belzona system leaflet TCC-15. The failed lining was removed & the concrete was prepared with floor grinders. The walls were then filleted with Belzona 4131 Magma screed. Two coats of Belzona 5811 Immersion Grade were then applied to provide corrosion protection.
