# Brewery vessel coating

ID: 7727

Industry: Food & Drink  
Application: TCC-Tanks and Chemical Containment Areas  
Substrate: Steel  
Products: \* Belzona 5892 ,

Customer Location: Scotland  
Application Date: April 2018

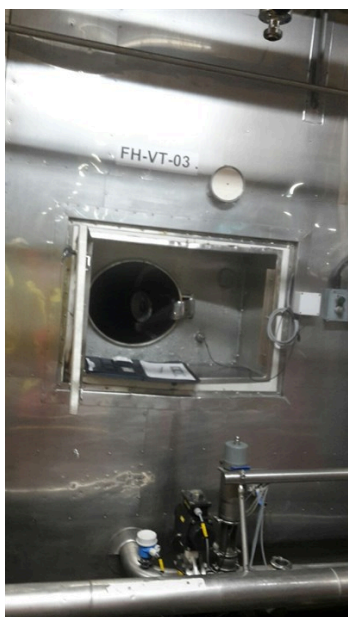
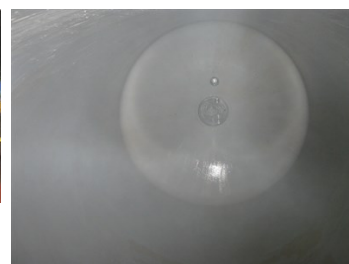
*The original lining had started to break down. A corrosion resistant system that would not taint the final product was required. Dust was not permitted to escape the working area due to production going on in the surrounding area.*

- \* 1 - Vessel manway ,
- \* 2 - Breakdown in original lining ,
- \* 3 - Habitat to contain any sponge media from the blasting process ,
- \* 4 - Belzona 5892 applied ,

The application was carried out in accordance with Belzona System Leaflet TCC-03. A sponge blast system was used to remove the

failed lining & to prepare the underlying metal. Two coats of Belzona 5892 were then applied. The coating was post cured at 30 degrees C to comply with the WRAS potable water requirements.
