Nuclear Plant Benefits from Belzonas Long-Lasting Pump Coatings

Customer Location: Nuclear Power Plant - Flamanville,
France

Application: CEP-Centrifugal Pumps

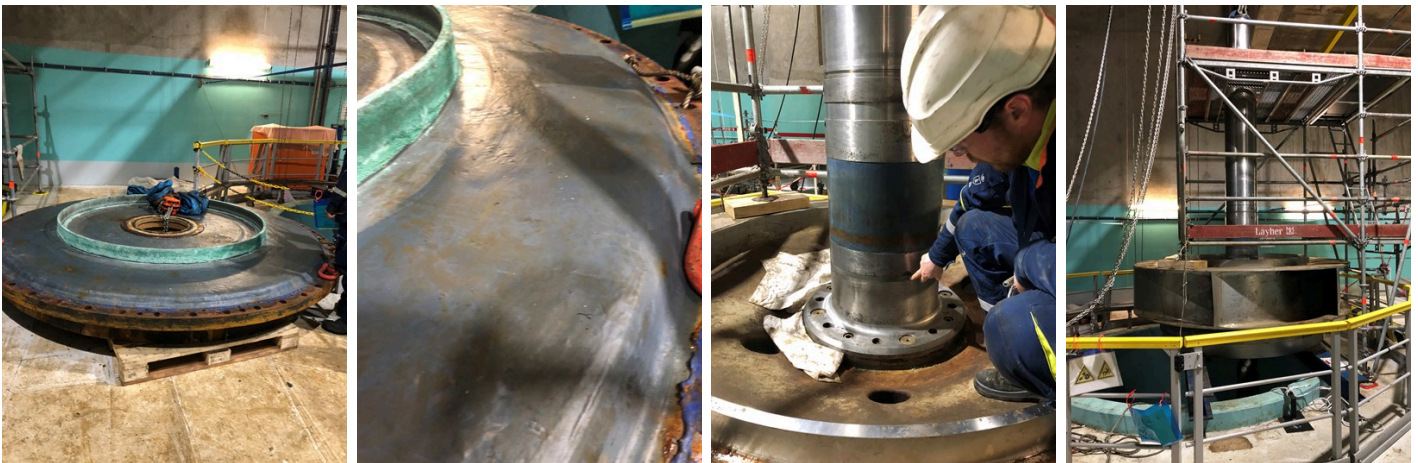
Photograph Descriptions

The sand and other solid particles suspended in the solution were causing erosion and wear damage on the pump lining and the maintenance team needed a solution to ensure continued operation of the equipment. In addition, the expectation of the solution was an in-service lifespan of at least 8 years, ruling out a significant number of alternative repair methods.

* 1.Pump removed from service for inspection 2.Inspection reveals the coating is still in excellent condition after 20 years 3. Coating frost blasted before application of Belzona 5821 4.Pump reinstalled with additional barrier protection ,

excellent erosion-corrosion resistance over that period. In this instance, the application was no different. Originally coated in 1998, the pump and coating were inspected 20 years later and found to still be in excellent condition. As a future-proofing measure, the Belzona Distributor frost blasted the coating and applied an additional layer of Belzona 5821 before returning to service. This high-performance system is ideally suited for equipment operating under immersion and erosive conditions and will extend the pump's life expectancy well beyond its original prescription.
