Belzona 4111 Repairs Shell and Secures Wedge Liners in a Ball Mill

Customer Location: Metal producer, Mykolaiv, Ukraine
Application Date: 2016

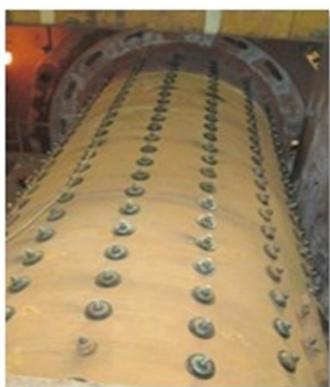
The wedge liners did not fit together perfectly. Overtime, they caused damage to and distorted the ball mill shell underneath. The refinery wanted to repair the damage and secure the wedge liners. The environment included bauxite and an alkaline solution at 80°C (176°F).

* 1. Ball mill, outer view 2. Ball mill, inner view 3. Shell repaired 4. Wedge liner secured ,
