Belzona 4111 Repairs Shell and Secures Wedge Liners in a Ball Mill

ID: 7732

Customer Location: Metal producer, Mykolaiv, Ukraine
Application Date: 2016

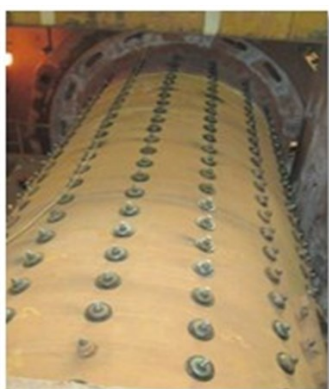
* 1. Ball mill, outer view 2. Ball mill, inner view 3. Shell repaired 4. Wedge liner secured ,
