Cooling Tower protected thanks to Belzona

Industry: Sugar
Application: TCC-Tanks and Chemical Containment Areas
Substrate: Concrete
Products: * Belzona 4111 (Magma Quartz) ,
* Belzona 5811 (Immersion Grade) ,

Customer Location: Sugar Mill, France
Application Date: July 2018

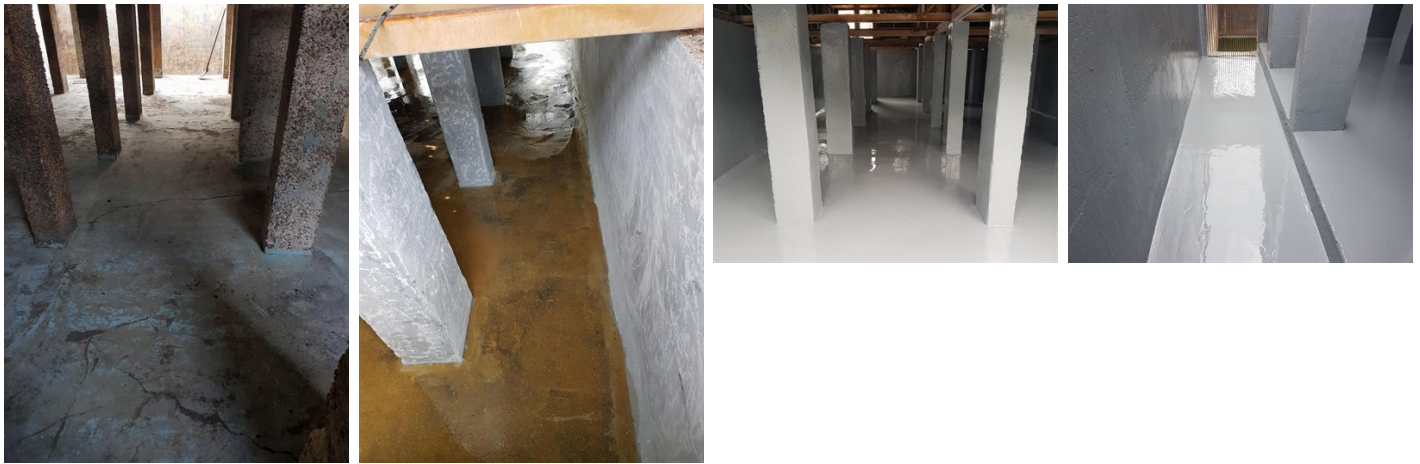
Photograph Descriptions

General corrosion of the concrete basin

- * 1- Corrosion of the concrete and exposed steel re-bar ,
- * 2- Repair of the concrete work using Belzona 4111 ,
- * 3- Work completed with application of belzona 5811 ,
- * 4- Work completed ,

Application was carried out in accordance with Belzona Know-How System Leaflet TCC-15.

Belzona 4111 and 5811 are ideally suited for the long term protection of cooling water basins given their high adhesion values and excellent corrosion resistance and performance in immersion up to 50°C.
