# Nuclear Plant Benefits from Using Belzonas Long Lasting Pump Coatings

ID: 7735

Application: PDP-Positive Displacement Pumps

Customer Location: Flamanville, France

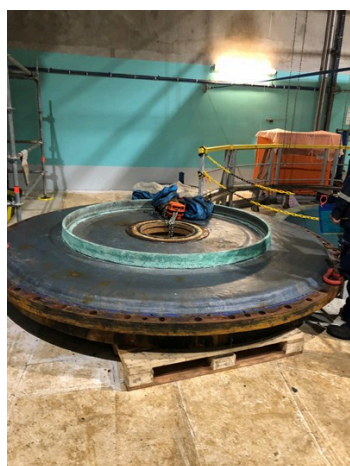
- \* 1. Pump removed from service for inspection ,
- \* 2. Inspection reveals the coating is still in excellent condition after 20 years ,
- \* 3. Coating frost blasted before application of Belzona 5821 ,
- \* 4. Pump reinstalled with additional barrier protection ,

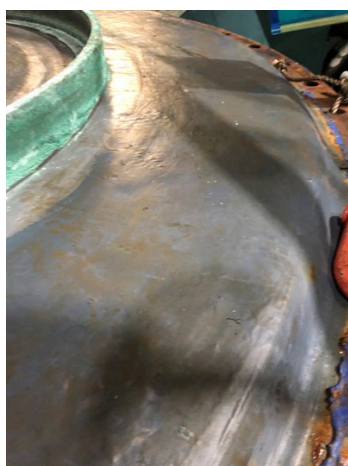
This power station had been coating cooling water pumps with Belzona for over 25 years, with each application demonstrating excellent erosion-corrosion resistance over that period. In this instance, the application was no different. Originally instated in 1998, the pump and coating were inspected 20 years later and found to still be in excellent condition. As a future-proofing measure, the Belzona Distributor frost blasted the coating and applied an additional layer of Belzona 5821 before returning to service. This high-performance system is ideally suited for equipment operating under immersion and erosive conditions and will extend the pump's life expectancy well beyond its original prescription.
