# Belzona prevails after several campaigns of protection for this Auger screw

Application: *SHM-Solids Handling Machinery*

Customer Location: *Sugar Mill, France*

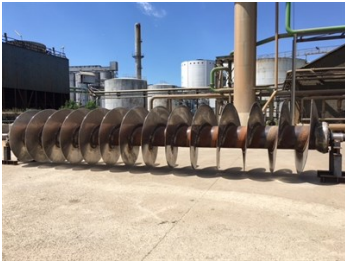
*Wear due to continuous abrasion of the sugar beets as well as gravels, rocks and sand*

Screw conveyor moving sugar beets across the plant

Application was carried out in accordance with Belzona Know-How System Leaflet SHM-14. Belzona 1812 was applied onto the first 3 metres of the screw for additional abrasion resistance.
