BELZONA UPGRADES TANK FARM FLOOR

ID: 774

Customer Location: *AFB Pet Food Additive Manufacturer,
OFallon, MO*

Application: *FPA-Floor Problem Areas*

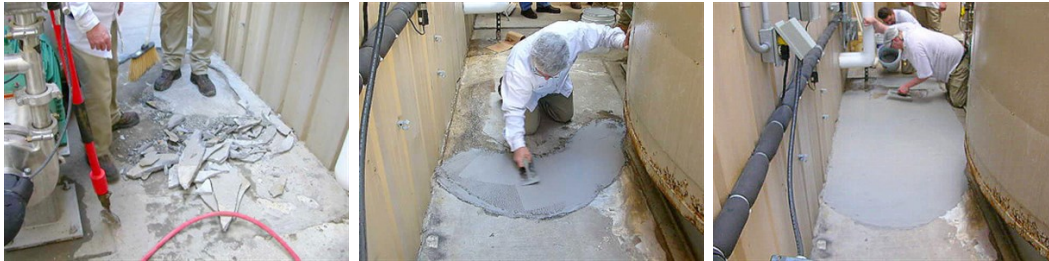
Photograph Descriptions

Thin top layer of concrete delaminated allowing Bacteria growth and unacceptable appearance.

* Old concrete , * Start of application , * Finished job ,

Application carried out in accordance with Belzona Know-How System Leaflet FPA-1
