# BELZONA UPGRADES TANK FARM FLOOR

Customer Location: AFB Pet Food Additive Manufacturer,  
OFallon, MO

Application: FPA-Floor Problem Areas

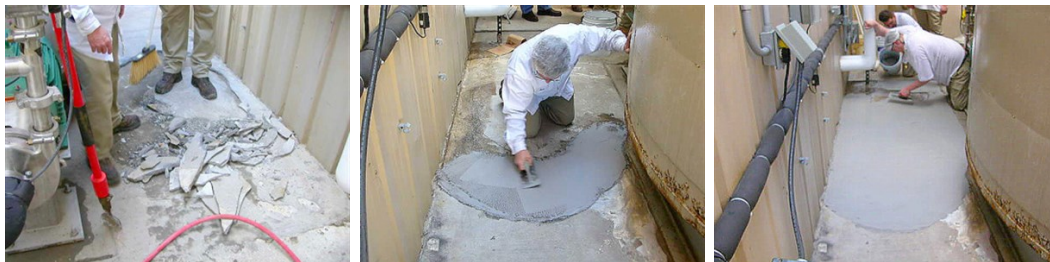
*Thin top layer of concrete delaminated allowing Bacteria growth and unacceptable appearance.*

\* Old concrete , \* Start of application , \* Finished job ,

Floor area around storage tanks

Application carried out in accordance with Belzona Know-How System Leaflet FPA-1
