# Belzona Repairs Private Residence Outdoor Pool Skimmers

ID: 7740

**Customer Location:** Nova Scotia, Canada  
**Application Date:** June 2018

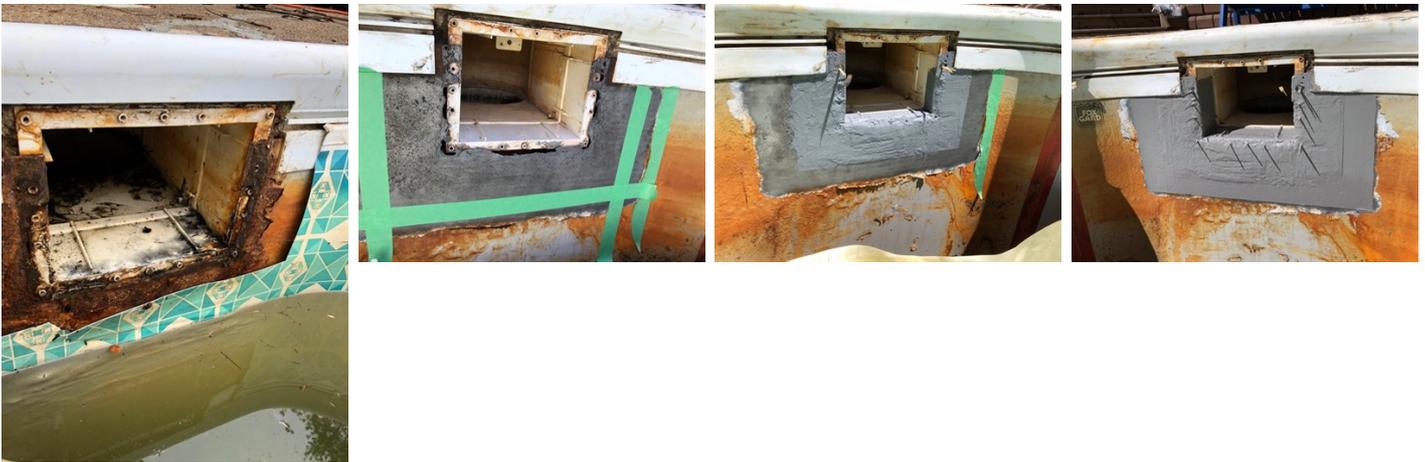
The customer was looking to do routine maintenance on the vinyl pool liner. When the liner was peeled back, there was heavy corrosion and metal loss on the steel backing plate around the skimmer housing areas. The customer wanted a Belzona solution to restore/repair the metal loss and prevent water from leaking behind the backing plate and skimmer housings.

- \* Before photo showing extent of corrosion around skimmer housing. ,
- \* Repair area bristle blasted and cleaned. ,
- \* Belzona 1161 used to repair metal loss around skimmer housing. ,
- \* Finished application with two coats of Belzona 3121. ,

Corrosion and erosion of steel backing plate around pool skimmers.

6" around the plastic skimmer housing was marked to define the repair areas. These areas were bristle blasted to remove loose paint and rust, and to provide a suitable anchor profile. The repair areas were then cleaned with Methyl Ethyl Keytone (MEK) to remove all contaminants. The repair areas were re-taped 3" around the skimmer housings before beginning the metal repair.

Belzona 1161 was then brushed into the steel substrate and plastic skimmer housings. Additional Belzona 1161, wetted into Belzona 9341 Reinforcement Tape, was used to re-build the metal loss and bridge the void between the steel backing plate and skimmer housings. Once Belzona 1161 was allowed to cure, Belzona 3121 (MR7) was applied over the entire repair areas, as two coats, preventing any future water ingress.
