# Belzona Cuts Down a Concrete Shimming Application Time from 45 to 7 days

ID: 7741

Industry: Pulp & Paper

Customer Location: Paper Mill, Brazil

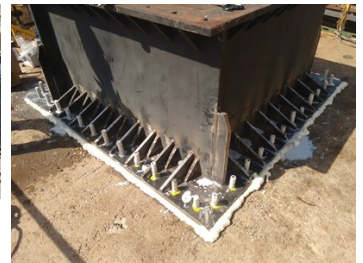
*Due to constant movement and vibration created between the skid and the concrete foundation, the heads of the bolts holding the base down started to break off.*

- \* View of the Crane ,
- \* Concrete foundation before ,
- \* Application in progress including new anchor holes being drilled ,
- \* Completed application ,

First, 48 new holes were drilled to install newly fabricated bolts. Then the skid was positioned over the concrete base, secured and aligned with 4 metal bars in 4 points around the perimeter of the skid, and positioned on top of the concrete base. Belzona 4111 and Belzona 4151 were then mixed and injected into each of the holes. Anchor bolts were inserted, and excess of product was used to fill the annular space under the equipment.
