Belzona Repairs and Protects Bow Thruster

ID: 7744

Industry: *Marine*
Application: *SOS-Ships and Offshore Structures*

Customer Location: *Shipyards, Yalova, Turkey*
Application Date: *March 2018*

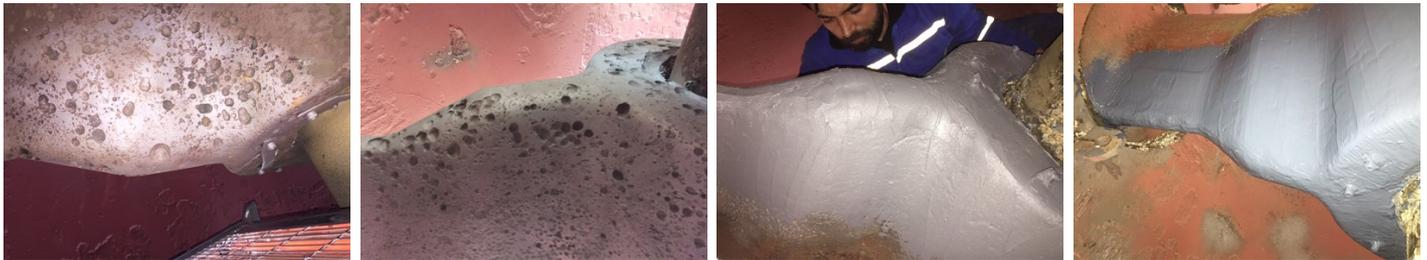
Photograph Descriptions

The bow thruster body was showing severe erosion and corrosion damage due to the marine environment.

- * 1- Severe damage clearly visible on bow thruster body. ,
- * 2- Close-up view after successful grit blasting. ,
- * 3- Repair of damaged surface with Belzona 1111 (Super Metal). ,
- * 4- Coating of the surface with Belzona 1321 (Ceramic S-Metal). ,

Ship was scheduled to leave the dry dock within 2 days. Immediately following surface preparation, Belzona 1111 (Super Metal) was applied to repair the pitted surface. A great advantage of Belzona 1321 (Ceramic S-Metal) is that it can be applied within a few hours on top of Belzona 1111 (Super Metal), without the need for further surface preparation. The work was completed within 5 hours. Belzona 1321 (Ceramic S-Metal) has a relatively short curing time until it is suitable for immersion, giving an added advantage, as it allowed a quick return to service.
