Belzona protects steel joints on large suspension bridge

ID: 7745

Customer Location: Greece
Application Date: July 2018

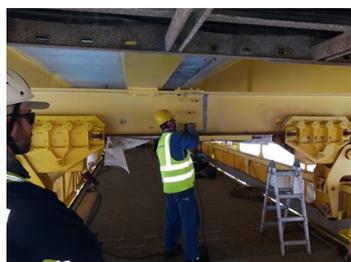
* 1. Preparation being carried out
* 2. Preparation completed
* 3. First coat of Belzona 3412 applied
* 4. Completed application ,

Application was carried out in accordance with an amended version of System Leaflet GSS-11.
