Belzona protects steel joints on large suspension bridge

ID: 7745

Customer Location: Greece
Application Date: July 2018

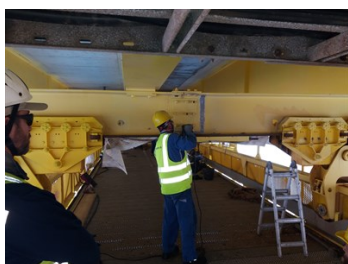
* 1. Preparation being carried out
2. Preparation completed
3. First coat of Belzona 3412 applied
4. Completed application ,

Corrosion in the bolt areas of the steel joints caused by insufficient protection from the existing paint. Due to the movement in the joints, the customer required a flexible coating. They wanted a system that would allow them to later inspect the bolts.

The existing paint was insufficient to protect the joint areas as it didn't have the edge retention to get good coverage of the complex geometry in this area. Due to the movement in the substrate, traditional protection systems were not suitable as these may crack in service. An added benefit for the customer is the ability to inspect the bolts at a later date easily.
