# Health District HVAC Tube Sheet Repaired with Belzona

**Industry:** Heating, Ventilation & Air Conditioning  
**Application:** HEX-Heat Exchangers  
**Substrate:** Carbon steel  
**Products:** \* Belzona 1111 (Super Metal) ,  
\* Belzona 1321 (Ceramic S-Metal) ,

**Customer Location:** New Zealand  
**Application Date:** August 2018

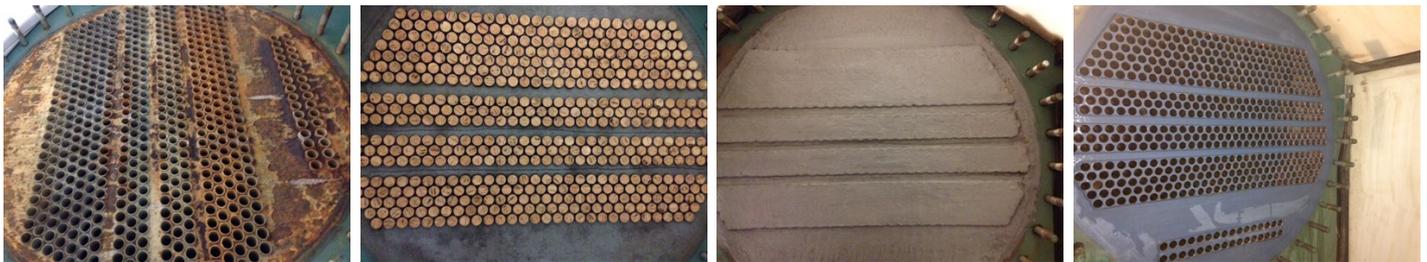
The tube sheet was severely corroded.

- \* Corroded tube sheet before application. ,
- \* Tube sheet after blasting. ,
- \* Belzona 1111 application onto the tube sheet. ,
- \* Completed application. ,

The application was carried out in accordance with Belzona Know-How System Leaflets HEX-1, HEX-2

The tube sheet was undergoing severe corrosion. The Customer's initial plan was to replace the entire tube sheet. Belzona methodology was presented as an alternative approach. The methodology was selected due to similar successful applications being done across the country for different industries. Belzona 1111 was used for rebuilding and Belzona 1321 was used for corrosion protection. These products were chosen as they had a short curing time.
