# FAST REPAIR OF BUTTERFLY VALVES WITH BELZONA ELASTOMERS RETURNS VESSEL TO SERVICE ON TIME

ID: 7754

Industry: Marine  
Application: VPF-Valves, Pipes and Fittings  
Substrate: Steel and existing rubber boot  
Products: \* Belzona 2121 (D&A Hi-Coat Elastomer) ,  
\* Belzona 2911 (Elastomer QD Conditioner) ,

Customer Location: Oregon, USA  
Application Date: September 3, 2018

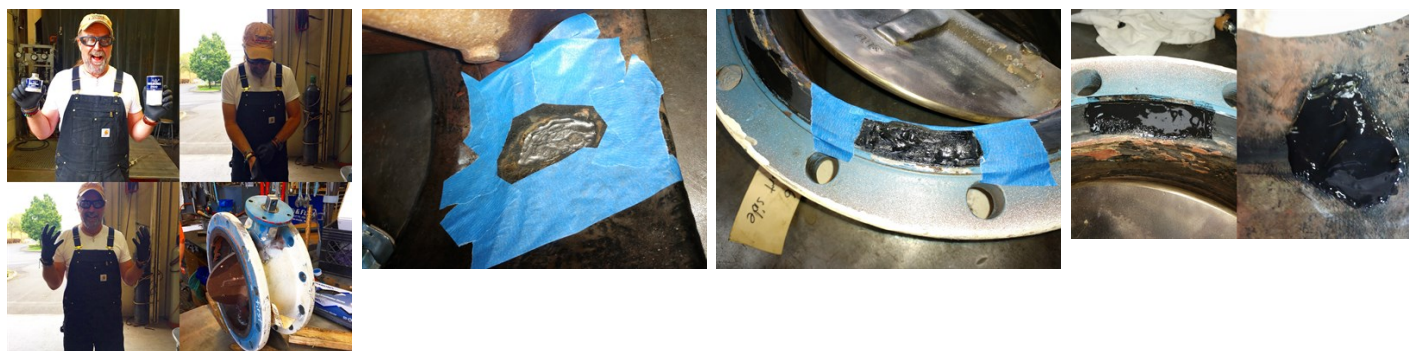
## Photograph Descriptions

Two valves were damaged as the rubber boot that provided the sealing surface had suffered damage. One appeared to be damaged by debris that was in the way while the valve was closed removing a large piece of rubber material. The other valve was damaged at the seating area probably during installation.

- \* 1. The Customer was excited to use Belzona to complete the repair. ,
- \* 2. Valve 1 with a large piece of rubber boot missing after surface preparation. ,
- \* 3. Valve 2 with damage on the seating area after surface preparation. ,
- \* 4. Repaired valves. ,

A modified version of Belzona System Leaflet VPF-3 was used to repair the valve lining. Loose material was removed and rubber

substrate was undercut to avoid a feathered edge. Application area was thoroughly degreased to remove contamination. Steel substrate was ground and rubber substrate was abraded with roughening brush to create a surface profile for Belzona 2121 (an ABS approved product) to achieve a mechanical bond. The surface was then conditioned with a light coat of Belzona 2911 and allowed to cure. The areas of concern were then masked off and then Belzona 2121 was poured into place. The masking tape was removed immediately and the product was left to cure. After the product had cured the repair areas were machined back to tolerance.

New boots were ordered for the valves but upon receiving them the boots did not fit. Due to a holiday weekened the Customer chose a Belzona solution as the product and technical assistance were available on short notice. After the product was cured the valves were hydro tested to ensure the valves would hold pressure and they passed the test.
