BELZONA PROTECTS AND REINFORCES THE WALLS OF AN 1800 SNOW RUN-OFF TUNNEL

Industry:
Application: WPA-Wall Problem Areas

Substrate: Concrete

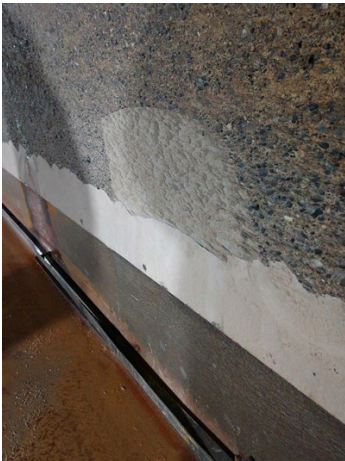
The water rushing through this 9' tunnel carries everything from silt to large boulders. This takes its toll on the concrete walls that were originally poured in 1953. In order to protect the walls, there were steel plates mounted on the lower portions, and in 2001, Belzona 4111 was applied from the top of the steel section up from 18" to 4' depending on the location inside the tunnel. After 17 years of exposure to this environment, the Belzona 4111 was starting to show some wear.

- * 17 year old Belzona 4111 (Magma-Quartz) ,
- * Belzona 4911 (TX Conditioner) applied ,
- * New Belzona 4111 (Magma-Quartz) applied ,
- * Application complete ,
