BELZONA PROTECTS AND REINFORCES THE WALLS OF AN 1800 SNOW RUN-OFF TUNNEL

Application: WPA-Wall Problem Areas

Customer Location: Washington, USA

Application Date: Summer 2018

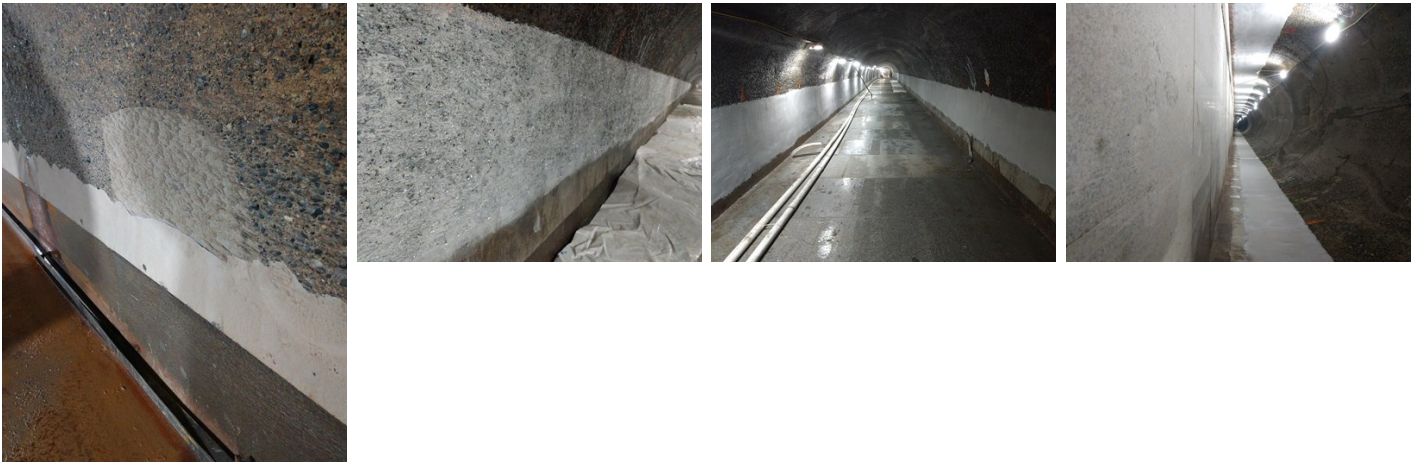
**Photograph Descriptions**

The water rushing through this 9' tunnel carries everything from silt to large boulders. This takes its toll on the concrete walls that were originally poured in 1953. In order to protect the walls, there were steel plates mounted on the lower portions, and in 2001, Belzona 4111 was applied from the top of the steel section up from 18" to 4' depending on the location inside the tunnel. After 17 years of exposure to this environment, the Belzona 4111 was starting to show some wear.

- * 17 year old Belzona 4111 (Magma-Quartz) ,
- * Belzona 4911 (TX Conditioner) applied ,
- * New Belzona 4111 (Magma-Quartz) applied ,
- * Application complete ,

A modified version of WPA-4 System Leaflet was used for this application. An MBX Bristleblaster was used to abrade the areas where the new Belzona 4111 was going to overlap the old Belzona 4111. The concrete wall was cleaned and checked for any loose areas before application. The areas varied in height, so depending upon that, the square footage was marked on the wall to ensure proper coverage of the Belzona 4911. After applying several units of Belzona 4911, the Belzona 4111 was mixed and applied with a trowel at approximately 1/4" overall thickness. Due to the extremely rough surface of the concrete, there were many areas that were considerably thicker, but the finish was kept smooth to avoid causing a source for cavitation during operation.
