A SHOWER AT A MINE MADE SAFE WITH BELZONA

ID: 7756

Industry: Mining & Quarrying
Application: FPA-Floor Problem Areas
Substrate: Concrete
Products: * Belzona 4911 (Magma TX Conditioner) ,
* Belzona 4111 (Magma-Quartz) ,
* Belzona 5911 (Ceramic Conditioner) ,
* Belzona 5111 (Ceramic Cladding) ,

Customer Location: Alaska, USA
Application Date: March 2018

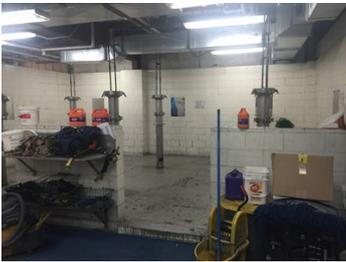
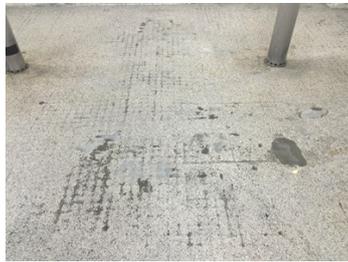
Originally, the floor was tiled. Eventually, it was damaged and an epoxy coating was used. It did not last too long before it began to flake off.

- * 1. Shower in original condition. ,
- * 2. Shower in original condition. ,
- * 3. Application is complete. ,
- * 4. Application is complete. ,
