# A SHOWER AT A MINE MADE SAFE WITH BELZONA

ID: 7756

Application: FPA-Floor Problem Areas

A shower room at a live-in camp at a mine in Alaska.

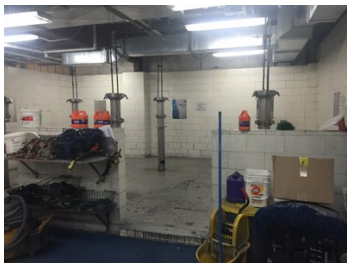
Originally, the floor was tiled. Eventually, it was damaged and an epoxy coating was used. It did not last too long before it began to flake off.

- \* 1. Shower in original condition. ,
- \* 2. Shower in original condition. ,
- \* 3. Application is complete. ,
- \* 4. Application is complete. ,

The application was carried out in accordance with a modified version of FPA-1 System Leaflet. The entire floor was prepped with a concrete grinder. The existing epoxy was removed, and the surface of the concrete was smoothed off leaving clean fresh concrete. Belzona 4911 and 4111 were applied over the entire floor to smooth off the irregularities and fill in the damage that was present from where the grout lines were with the original tile. Once that was completed, Belzona 5911 was applied with a semi-fine

alumina oxide aggregate to provide a safe slip-free floor. Following the Manufacturer's Instructions For Use, Belzona 5111 was applied in two coats, first white, then gray as the Customer chose.
