BELZONA 1212 SEALS A LEAK ON A WASTEWATER HOLDING TANK

ID: 7760

Industry: Water / Wastewater
Application: TCC-Tanks and Chemical Containment Areas
Substrate: Concrete
Products: * Belzona 1212 ,

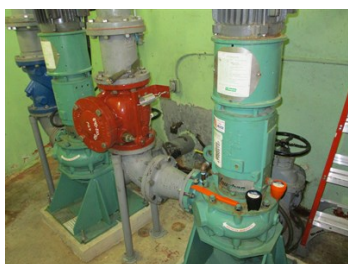
- * Sub-level wastewater lift station pump room. ,
- * Close up view of the leaking areas. ,
- * Belzona 1212 application complete. ,
- * Close up of one area of the application. ,

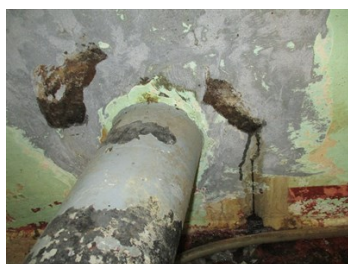
When the pipes were installed through the concrete wall, a grout was used to seal the area around the pipe. After many years of use, the grout began to fail, resulting in raw sewer water leaking into the pump room.

The application was carried out in accordance with TCC-5 Belzona System Leaflet. A grinder was used to remove the paint and the loose and damaged grout around the pipe. The leak was depressurized by lowering the contents of the concrete tank. The crack was explored until it became clear we were into solid concrete and had identified the exact location of the source of the leak. We discovered the raw sewer water was coming through on the bottom right area, but was splitting and coming through the wall there, as well as coming through the wall in the top left area. Both areas were packed full of Belzona 1212 and smoothed over so the Customer could repaint the wall later.
